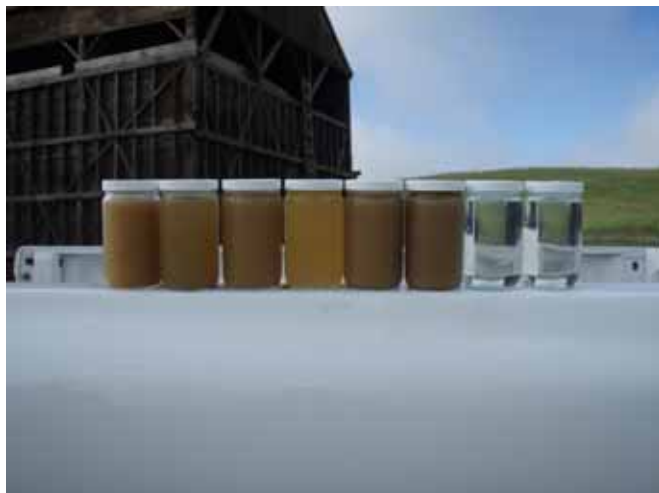
Figure 1: Samples collected by Dept. of Fish and Game (DF&G) during their 25 January 2009 investigation. From left to right, samples are moving from the Property and down Peaslee Creek; the last two samples are from upstream Tuolumne River.

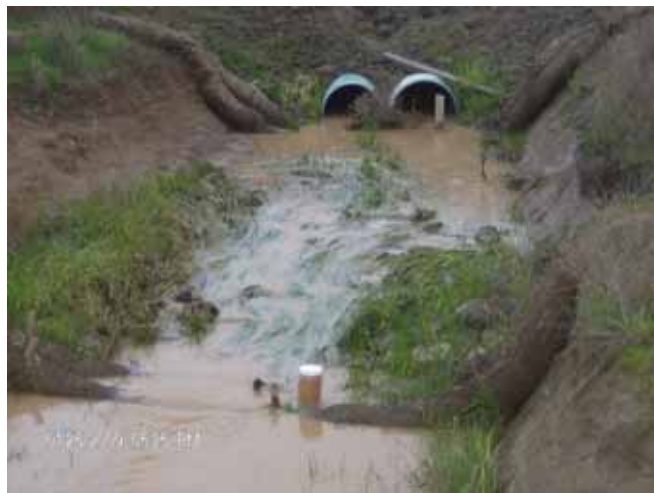
Figure 2: Photo submitted by Lt. McKay. Taken during the DF&G 25 January investigation. Shows sediment discharge from Stanislaus Almond Ranch property; Sample 3 site and significant flow and sediment load past the sediment control structures.

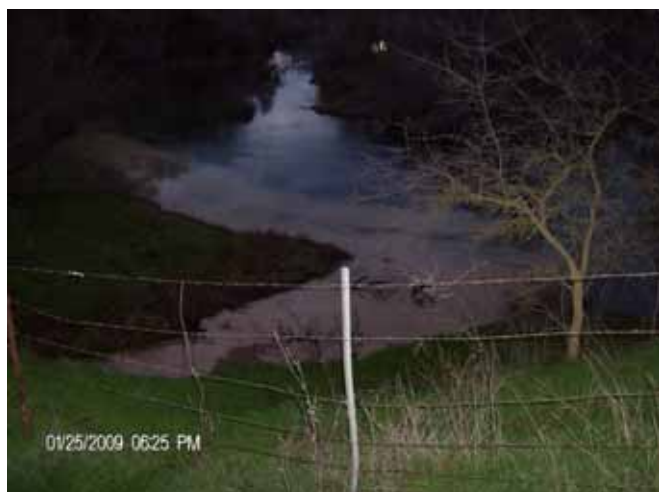
Figure 3: Photo submitted by Lt. McKay. Taken during the DF&G 25 January investigation. Peaslee Creek flowing into the Tuolumne River.
